# COLD CATHODE FLUORESCENT TUBES

## Brightness Decay Curve

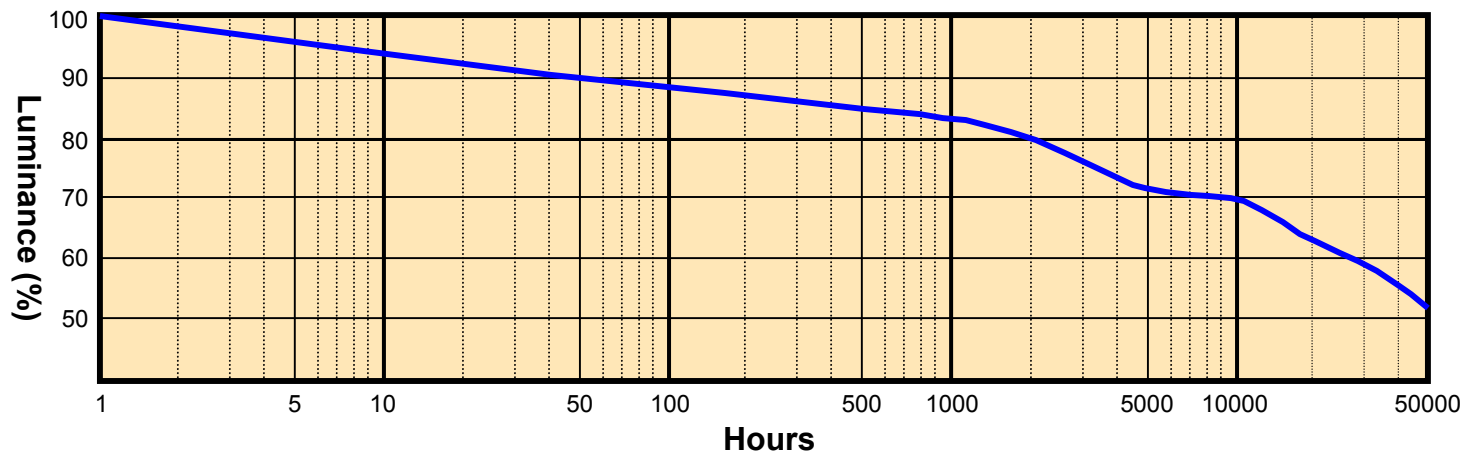
**Lamp Luminance Decay**

There are many factors that affect how bright a given backlight design will be such as lamp current, temperature, tube diameter, gas mixture and the partial pressures of its components. Over time, the luminous output of a lamp will decay, depending largely on how much mercury remains in the tube in vapor form. Additionally, the reflector behind the lamps can also degrade depending on the average operating temperature. At 80°C, the reflectance may drop to 70% after 10k hours, and after only 4k hours at 100°C, it may be as low as 20%. At 70°C, however, there is virtually no change in the reflector efficiency. The following semi-log plot shows the relationship between lamp brightness and time. As can be seen from the chart, a large percentage of the brightness is lost during the first few hundred hours of operation.

PLEASE NOTE: The curve shown is approximate. The brightness of a particular backlight system may vary, depending on the color temperature setting that has been maintained over the majority of its operating history.
